COMPASS
COMMUNITY PLANNING ASSOCIATION
of Southwest Idaho

2020 Data Bike Pilot Report

May 2021

Report No. 07-2021

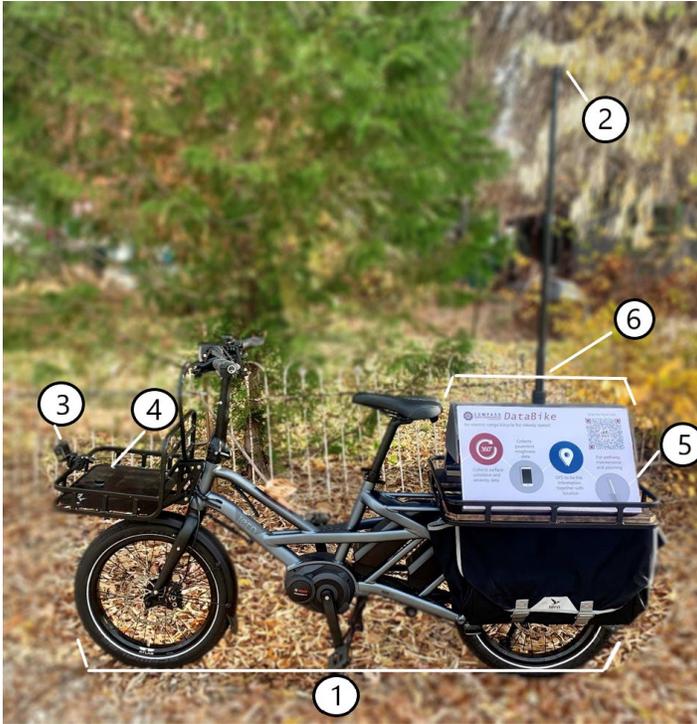
Figure 1. COMPASS Data Bike

The COMPASS Data Bike includes multiple pieces of equipment that work in tandem to collect roughness and other data as the bike is ridden (Figure 1).

1. Tern GSD Electric Cargo Bike
 - The electric-motor component of the bike is critical in order to keep the bike as close to a vertical orientation as possible, which is vital in the roughness app's measurement process. It is also outfitted with panniers for hauling gear.
2. Samsung 360° Camera
 - Used to photograph the surrounding environment; in the future, these photos will be imported to Google Maps.
3. Go Pro Hero 7 Camera
 - Used to photograph the pavement immediately below the bike. Photos can be compared to the measured roughness.
4. iPhone 7
 - Used to host the rRuf roughness measurement app (Figure 2).
5. Power Bank
 - Used as external power source for cameras and the iPhone in the field. This component isn't used for each deployment, but can be relied upon for longer deployments that could deplete battery levels.
6. Canopy
 - Used to stabilize the 360° camera.

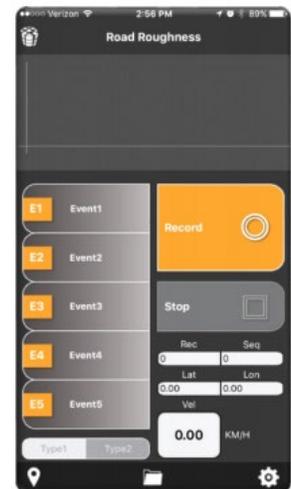
Figure 2. rRuf roughness measurement app

The rRuf app scores the condition of trails by using the iPhone's internal accelerometer and gyroscope to produce a standardized condition rating. The app includes an automated intelligent map that matches the data to the trail segment. Through a dashboard on the app, data collection can be monitored to identify gaps. The app is also able to produce averages and other statistics if a section of the trail is ridden multiple times. This helps alleviate any minor inconsistencies in the roughness data.

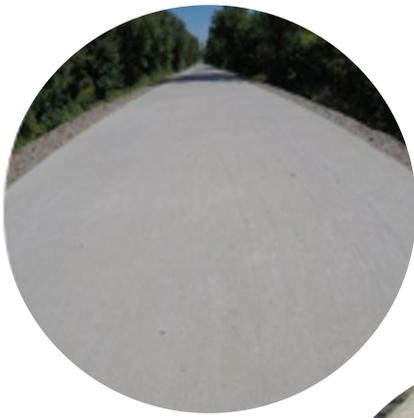
Very Smooth

Very smooth trails have nearly no cracking or vegetation growing on them. Variations in smoothness can be due to seams between concrete sections or other material spread across the trail.

The bike measures trail roughness using the iPhone's accelerometer data, which indicate significant changes in roughness of trail segments. Using this data, the trails are then categorized into five roughness categories, ranging from "very smooth" to "very rough" (Figure 3).

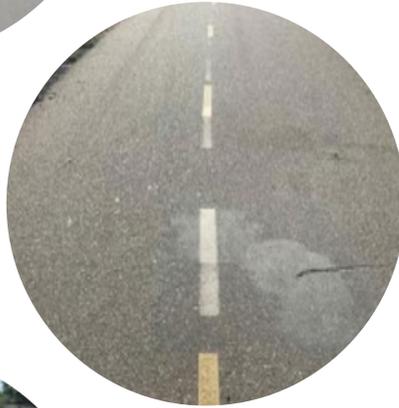
Smooth trails are typically in good condition, but are beginning to show signs of cracking. Cracking on smooth trails generally does not create discomfort for the rider.

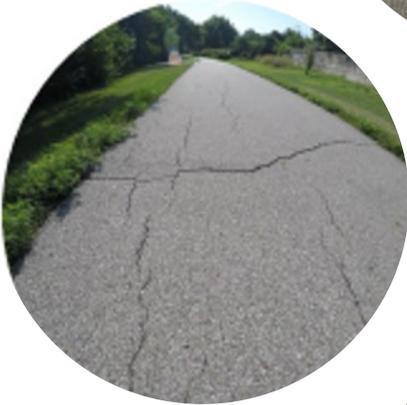
Fair trails are beginning to show increased wear and typically have more cracking. Cracking on trails in fair condition can cause minor discomfort for riders.

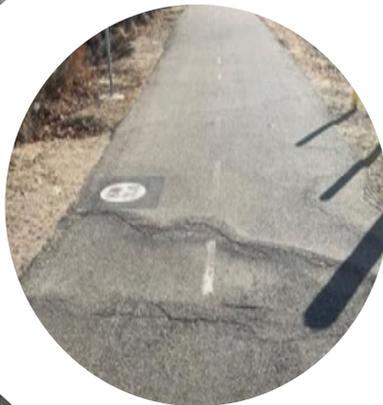
Rough trails show minor buckling or advanced cracking, with vegetation growing through the surface. These cracks are typically wider and deeper than cracks along fair condition trails and can cause discomfort for riders.

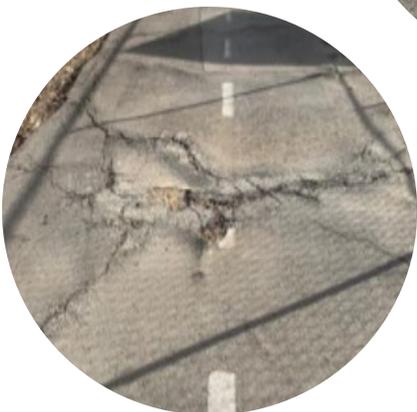
Very Rough

Very rough trails have cracking similar to trails in rough condition, but also have buckling of the trail surface. Very rough conditions on trails, if traversed, can cause discomfort for riders.

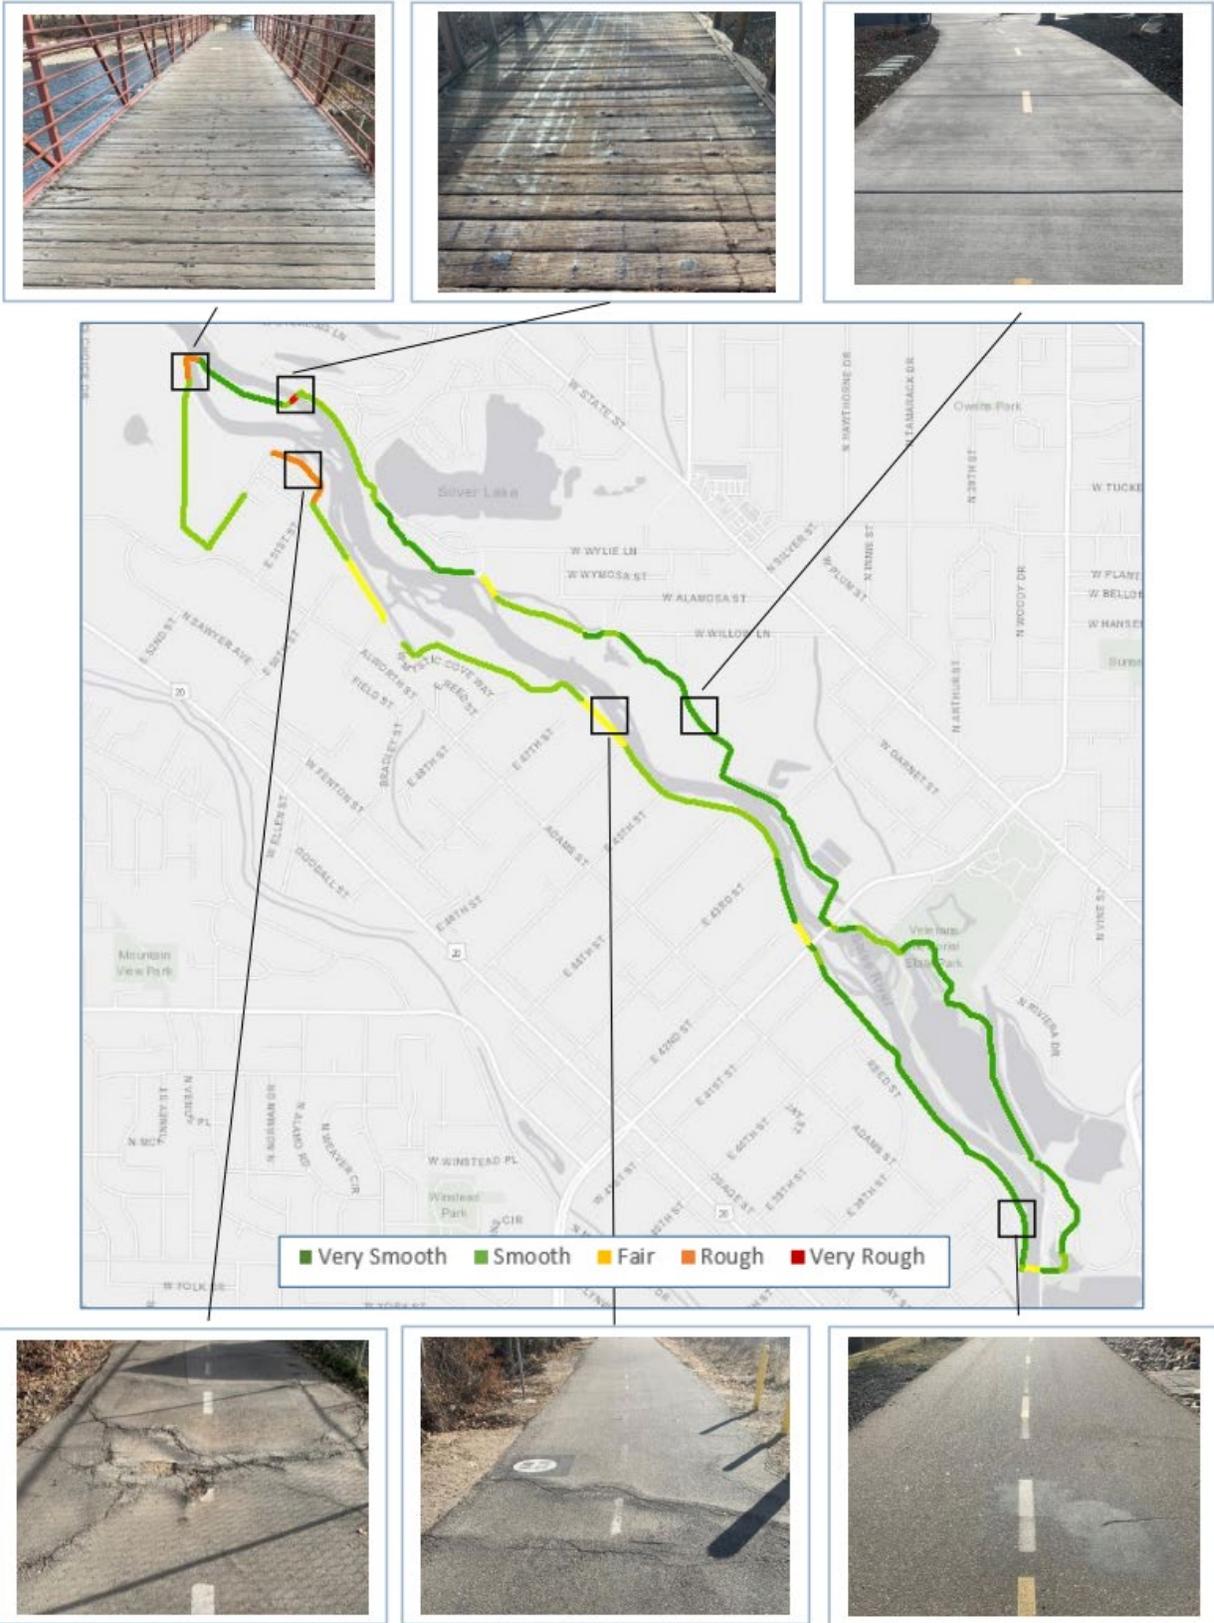
Figure 4. Roughness map of pilot segment

From this pilot, COMPASS was able to create a map showing the roughness along the pilot segment (Figure 4). It is important to note that the roughness data alone do not tell the full story, but they do provide insight into where problem sections may lie. For example, two different sections were rated as "rough" (orange), but based on visual inspection it was clear that the reasons for the "rough" ratings were very different – one section was impacted by tree roots while the other was a wooden bridge. These differences can be very important when using the data for decision-making.

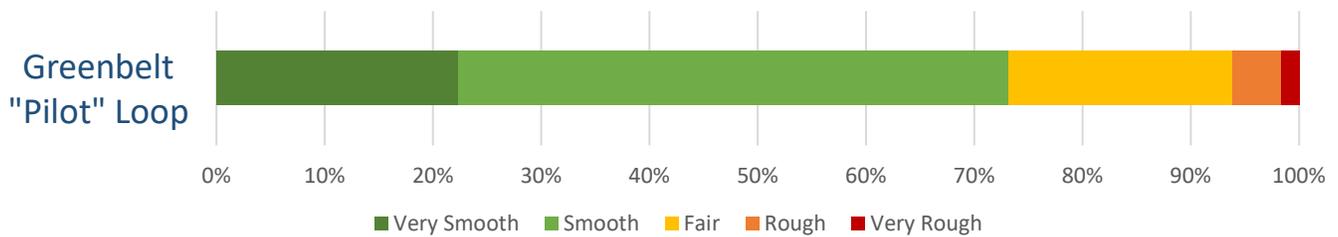
Figure 5. Percentages of pathway, by roughness, for pilot segment

In addition, the dashboard was used to produce a simple graphic showing the percentages of the pathway segment falling into each of the five categories (Figure 5). This graphic can be useful to gain understanding of each pathway segment's relative quality. It can also be used as a tool to compare different study areas. Among other things, these comparisons can be used to prioritize sections for improvements.
