**COMPASS**  
COMMUNITY PLANNING ASSOCIATION  
of Southwest Idaho

# 2023 Data Bike Report

Report Number 06-2024

February 2024

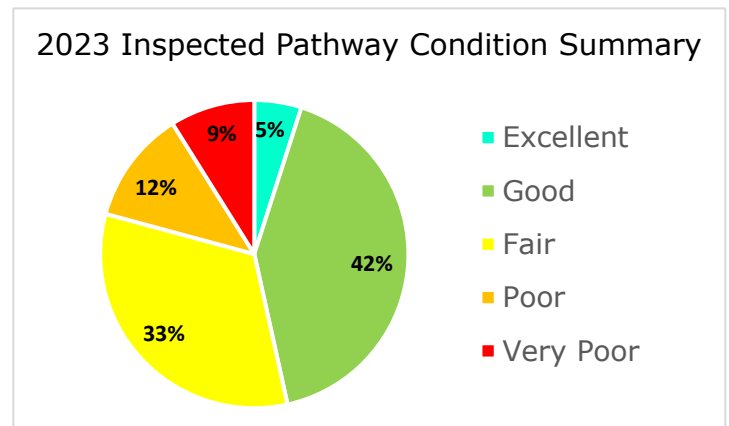
Figure 2. 2023 Inspected Pathway Condition Summary

In 2023, COMPASS' Bicycle and Pedestrian Counter Technician successfully inspected 54 miles, which accounts for 62% of the regional off-network paved pathway system (Figure 1). Of those pathways, 42% were in good condition, while 5% met the "excellent" standard (Figure 2). Significantly, 33% of the pathways were in fair condition, accompanied by 12% considered poor and 9% very poor. By focusing improvements on pathways in fair to very poor condition, there is a considerable opportunity to elevate the overall pathway conditions.

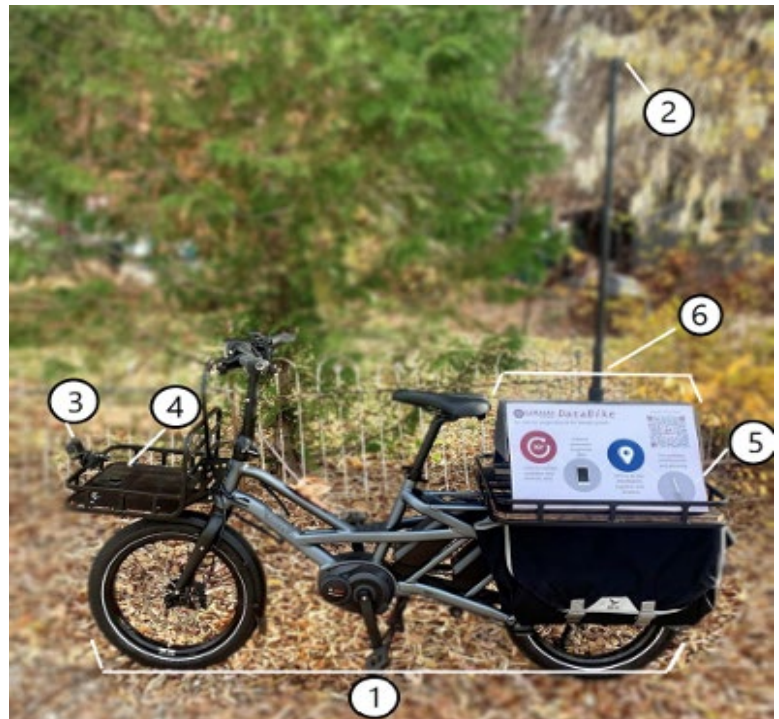
Figure 3: COMPASS Data Bike with Data Collection Equipment

The COMPASS Data Bike includes multiple pieces of equipment (Figure 3 and described below) that work in tandem to collect roughness and other data as the bike is ridden.

1. Tern GSD Electric Cargo Bike: Used to carry all data collection equipment in a smooth and standard manner. The electric motor component of the bike is critical to keep the bike as close to a vertical orientation as possible, which is vital in the roughness app's measurement process. It is also outfitted with panniers for hauling gear.
2. Samsung 360 Camera: Used to photograph the surrounding environment; in the future these photos will be imported to Google Maps.
3. Go Pro Hero 7 Camera: Used to photograph the pavement immediately below the bike. Photos can be compared to the measured roughness.

5. Power Bank: Used as an external power source for cameras and the iPhone in the field. This component isn't used for each deployment but can be relied upon for longer deployments that could deplete battery levels.
6. Canopy: Used to stabilize the 360-degree camera.

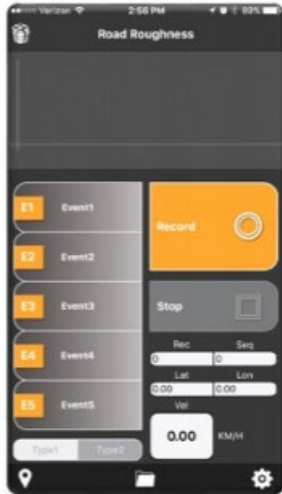
Figure 4. rRuf roughness Measurement App

4. iPhone 7 App: Used to host the rRuf roughness measurement app (Figure 4). The rRuf app scores the condition of trails by using the iPhone's internal accelerometer and gyroscope to produce a standardized condition rating. The app includes an automated intelligent map that matches the data to the trail segment. Through a dashboard on the app, data collection can be monitored to identify gaps. The app is also able to produce averages and other statistics if a section of the trail is ridden multiple times. This helps alleviate any minor inconsistencies in the roughness data.

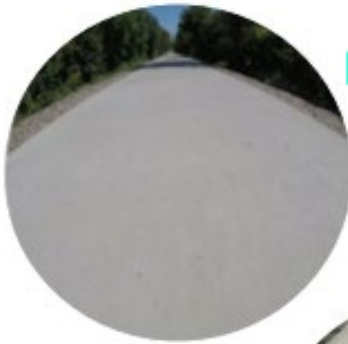
**Excellent – Very Smooth, Grade: A**

Very smooth trails have nearly no cracking or vegetation growing on them. Variations in smoothness can be due to seams between concrete sections or other material spread across the trail.

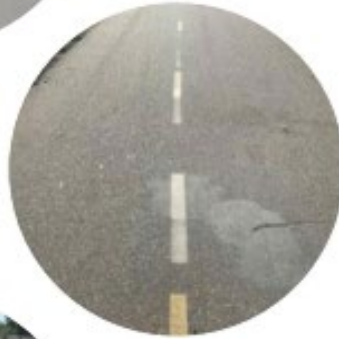
**Good – Smooth, Grade: B**

Smooth trails are typically in good condition, but are beginning to show signs of cracking. Cracking on smooth trails generally does not create discomfort for the rider.

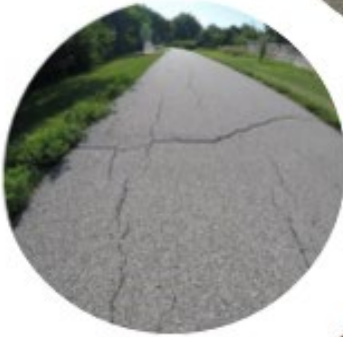
**Fair – Grade: C**

Fair trails are beginning to show increased wear and typically have more cracking. Cracking on trails in fair condition can cause minor discomfort for riders.

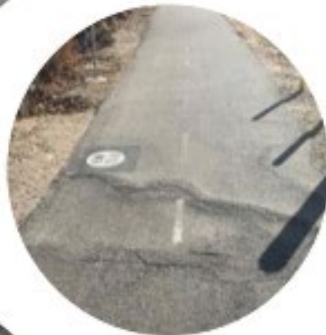
**Poor – Rough, Grade: D**

Rough trails show minor buckling or advanced cracking, with vegetation growing through the surface. These cracks are typically wider and deeper than cracks along fair condition trails and can cause discomfort for riders.

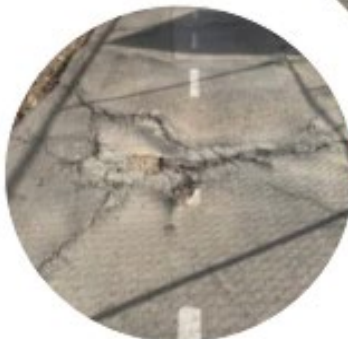
**Very Poor – Very Rough, Grade: F**

Very rough trails have cracking similar to trails in rough condition, but also have buckling of the trail surface. Very rough conditions on trails, if traversed, can cause discomfort for riders.

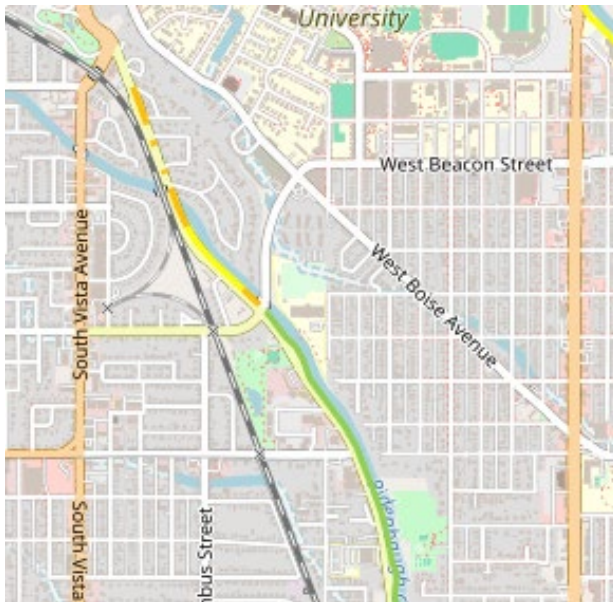
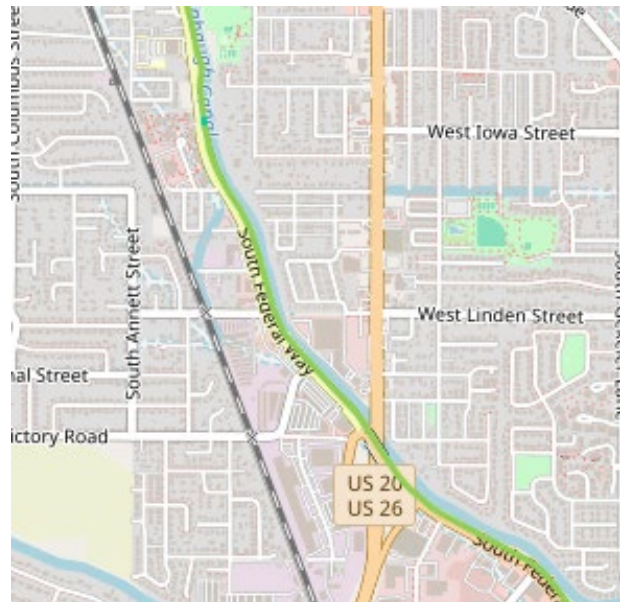
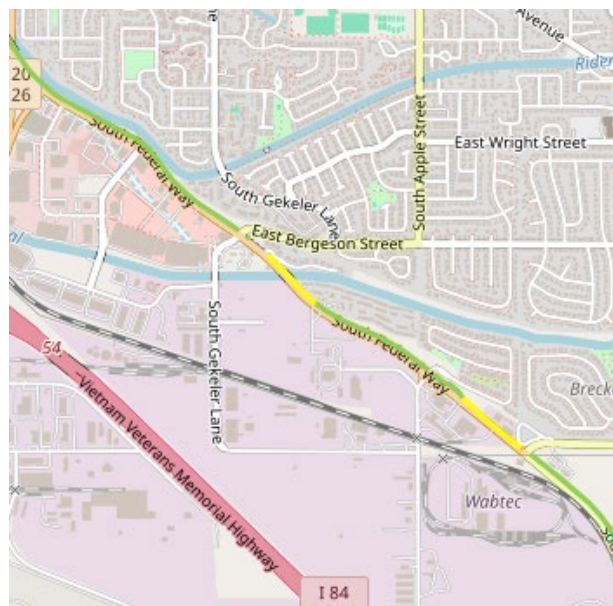
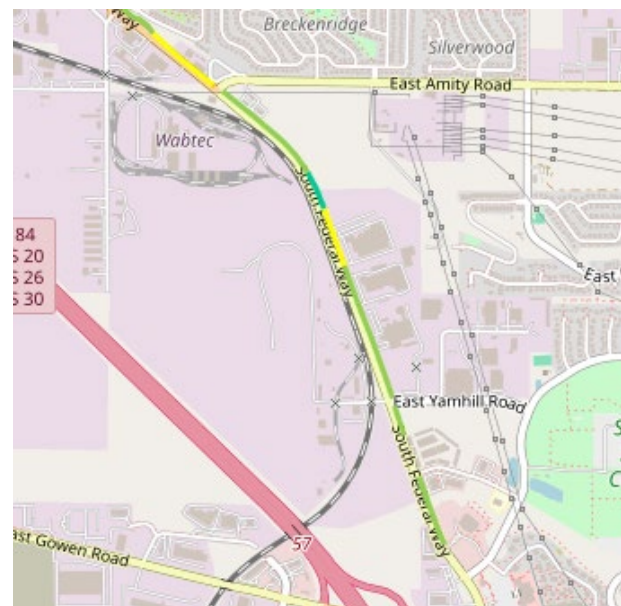
## Condition Maps

**B (3.2)**

**Location:** Southeast Boise, along Federal Way, from south Vista Avenue to east Lake Forest Drive

**Primary Surface:** Concrete

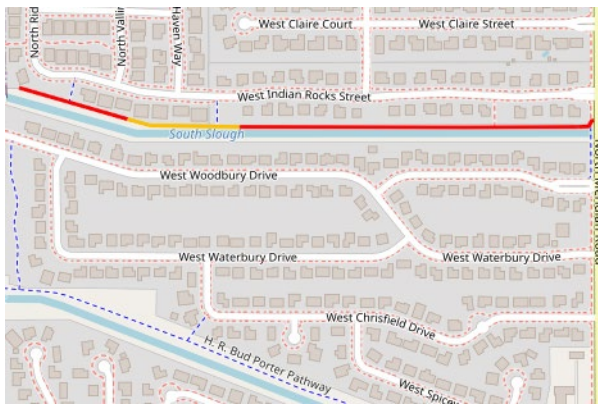
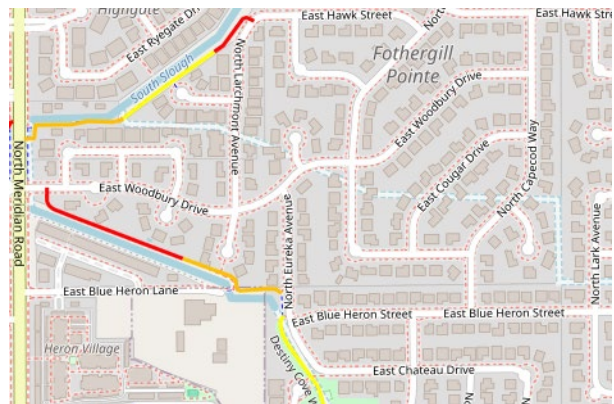
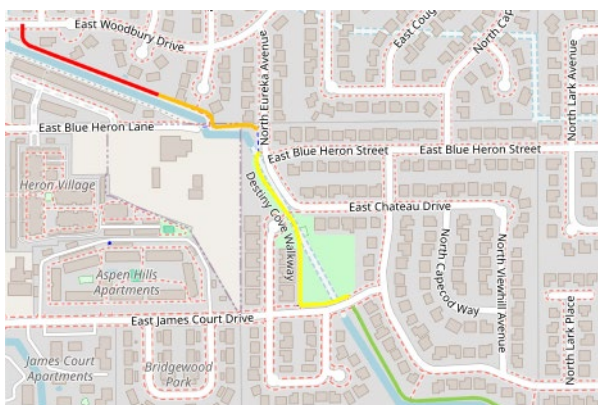
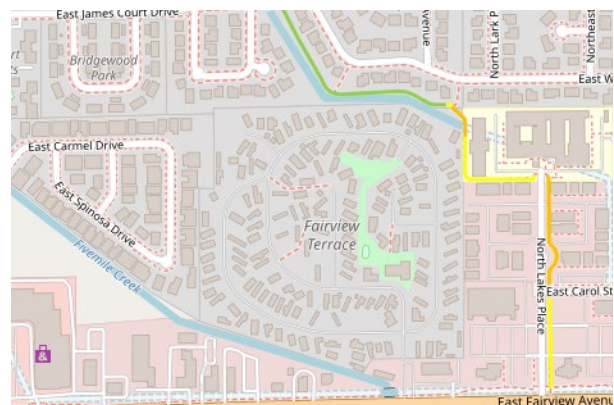
## Trail Photos and Condition Maps

**D** (5.7)

**Location:** North of Fairview Avenue

**Primary Surface:** Mixed (Concrete and Asphalt)

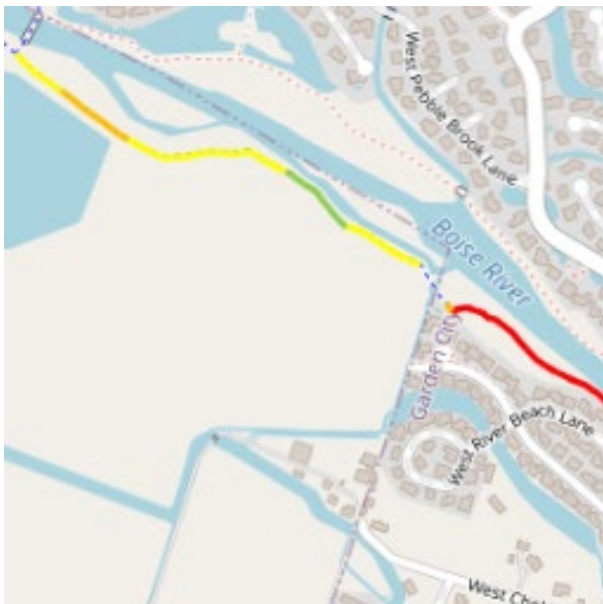
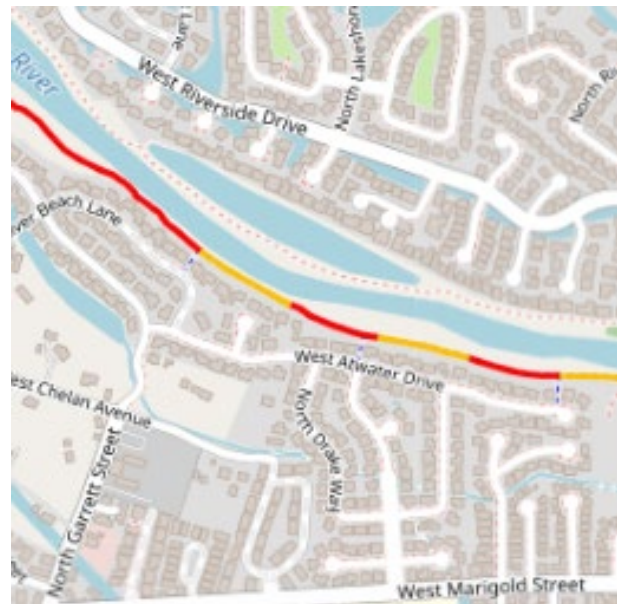
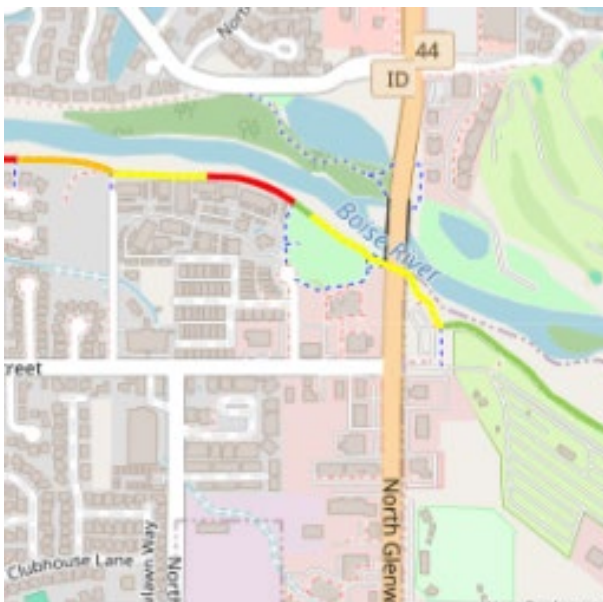
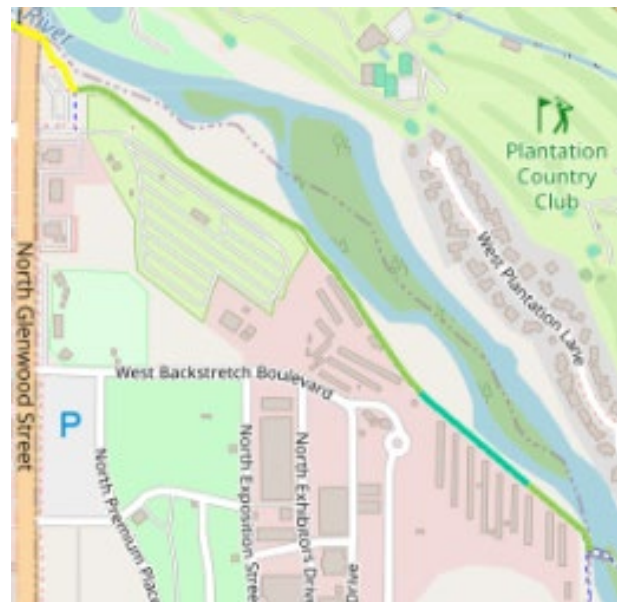
## Condition Maps

**C (4.8)**

**Location:** West Greenbelt Bridge (Between Eagle Road and Glenwood Boulevard) to Remington Street

**Primary Surface:** Asphalt

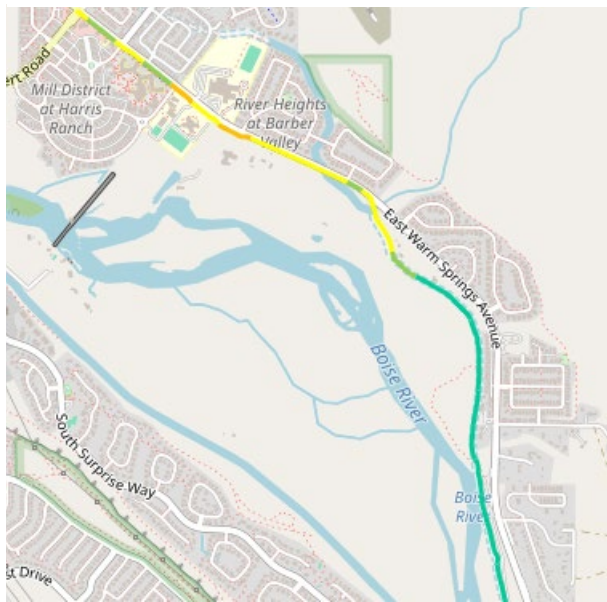
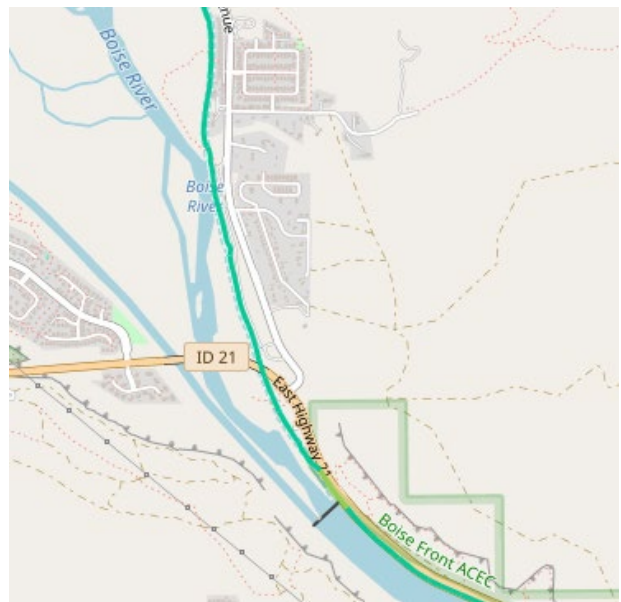
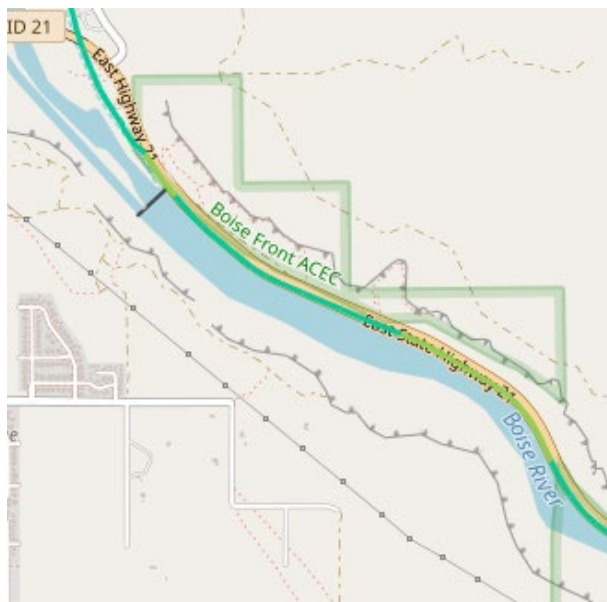
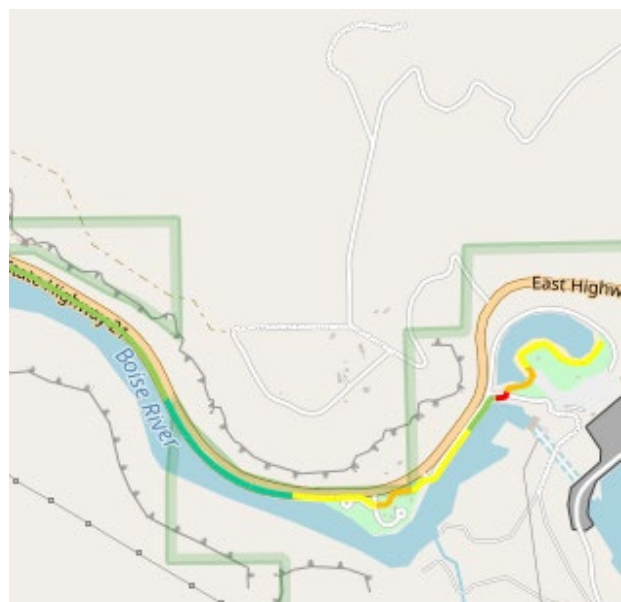
## Condition Maps

**B (3.0)**

**Location:** Eckert Bridge to Lucky Peak

**Primary Surface:** Mixed

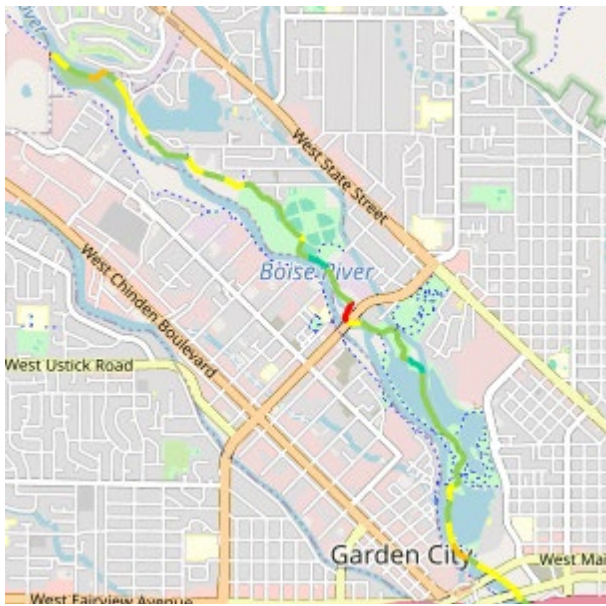
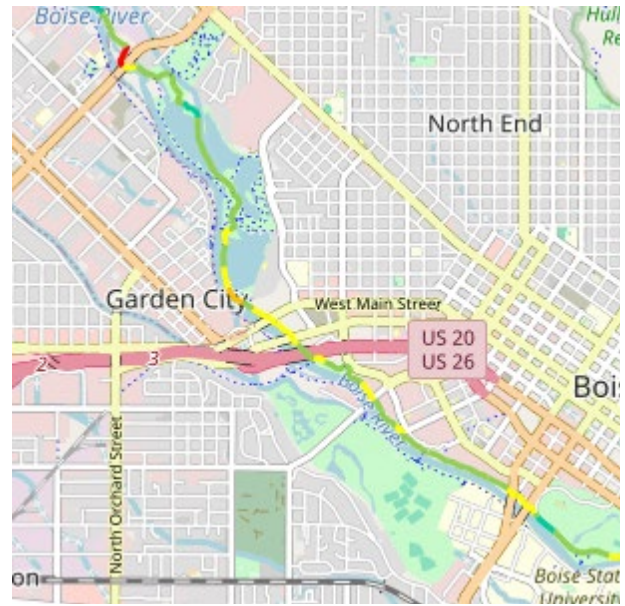
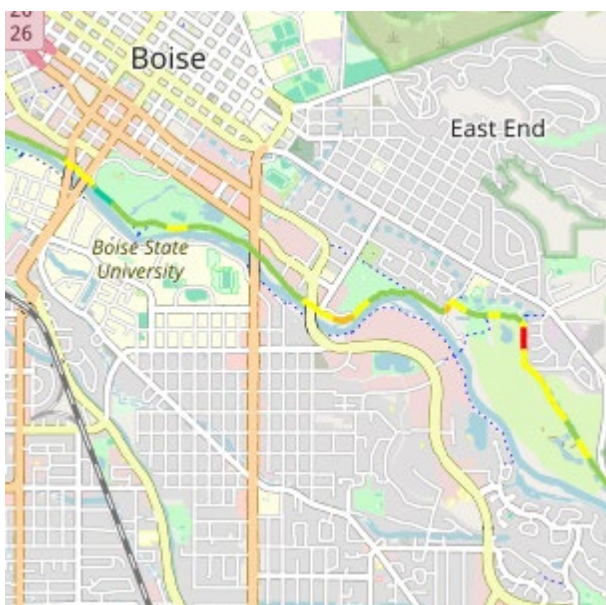
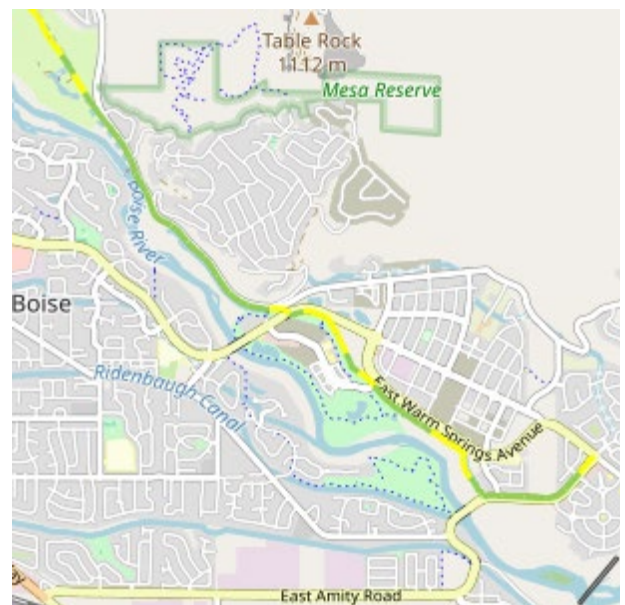
## Condition Maps

**C (3.5)**

**Location:** North of the river from Remington Street to Warm Springs Avenue

**Primary Surface:** Mixed

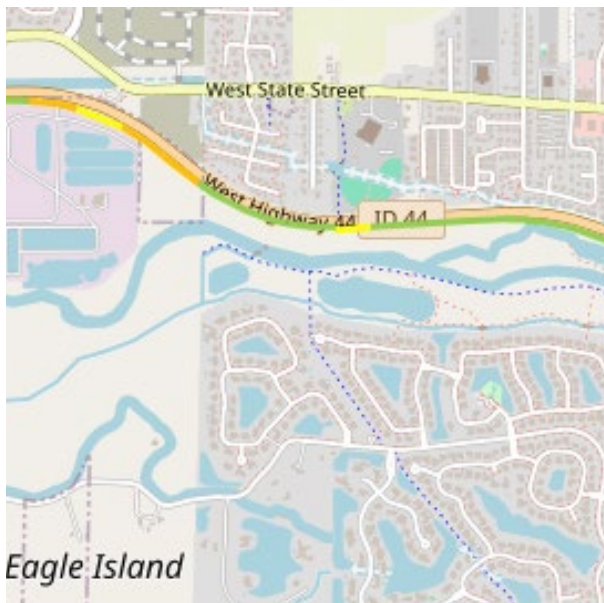
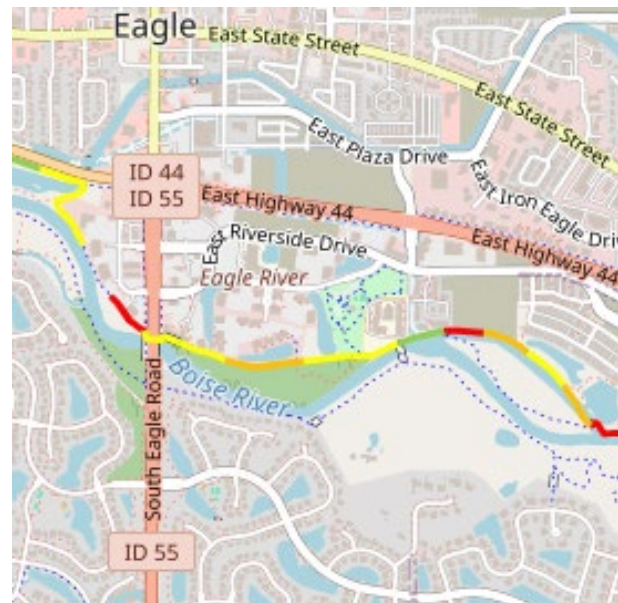
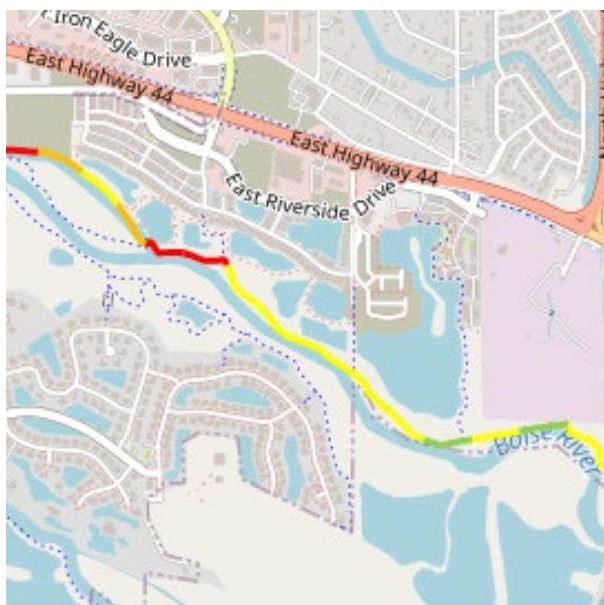
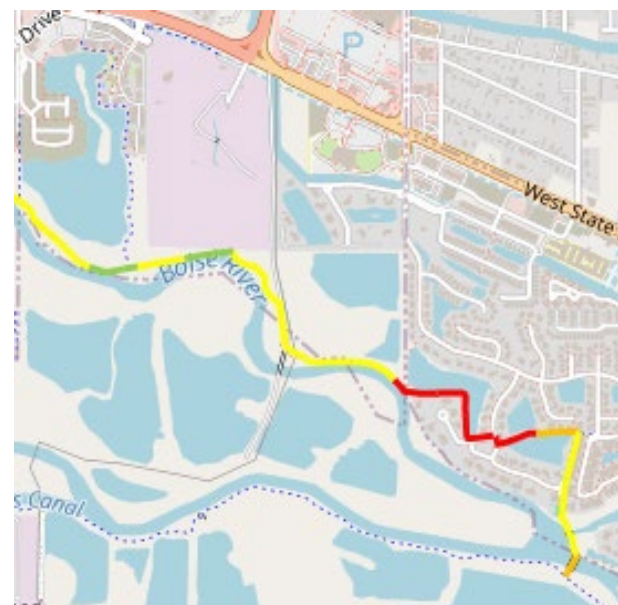
## Condition Maps

**C (5)**

**Location:** West Greenbelt Bridge to City of Eagle State Highway 44 Pathway

**Primary Surface:** Mixed

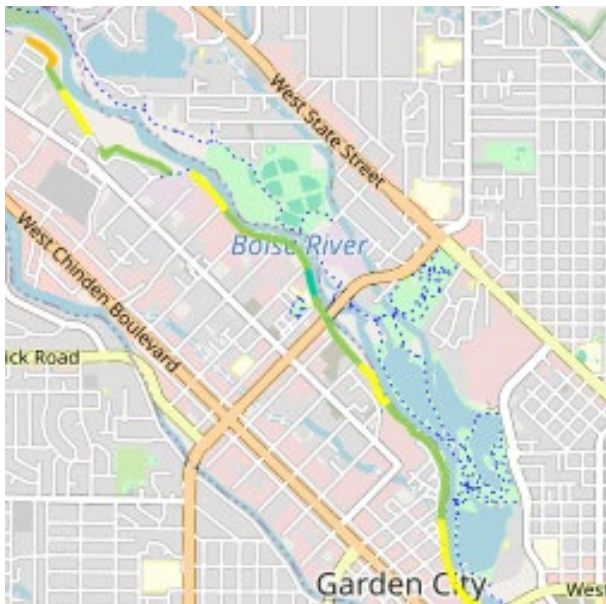
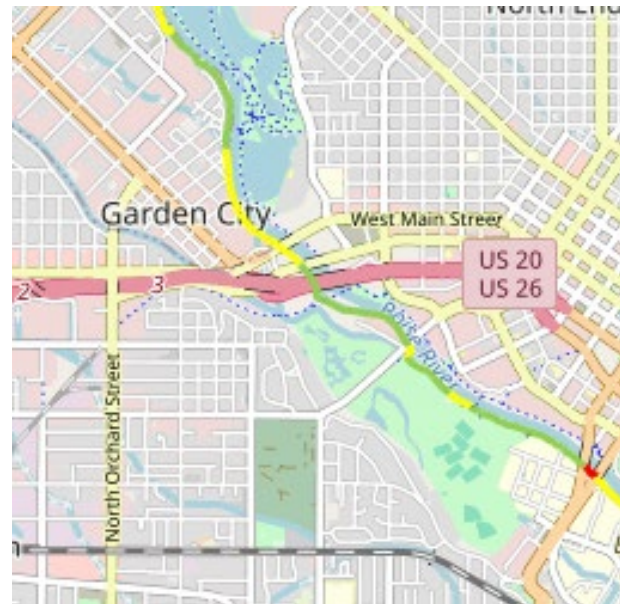
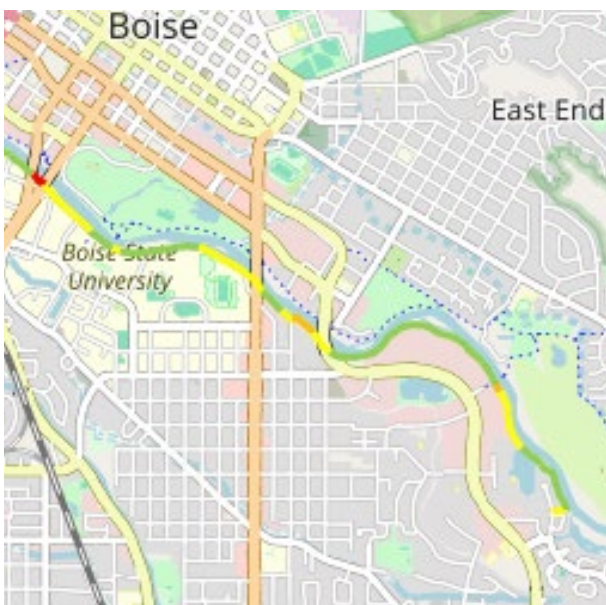
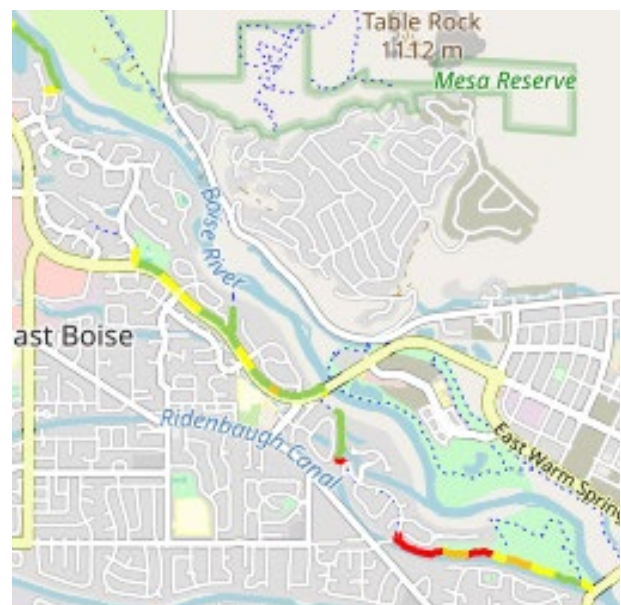
Condition Maps

**B (3.8)**

**Location:** South of the river from Remington Street to Eckert Bridge

**Primary Surface:** Mixed (Asphalt and Concrete)

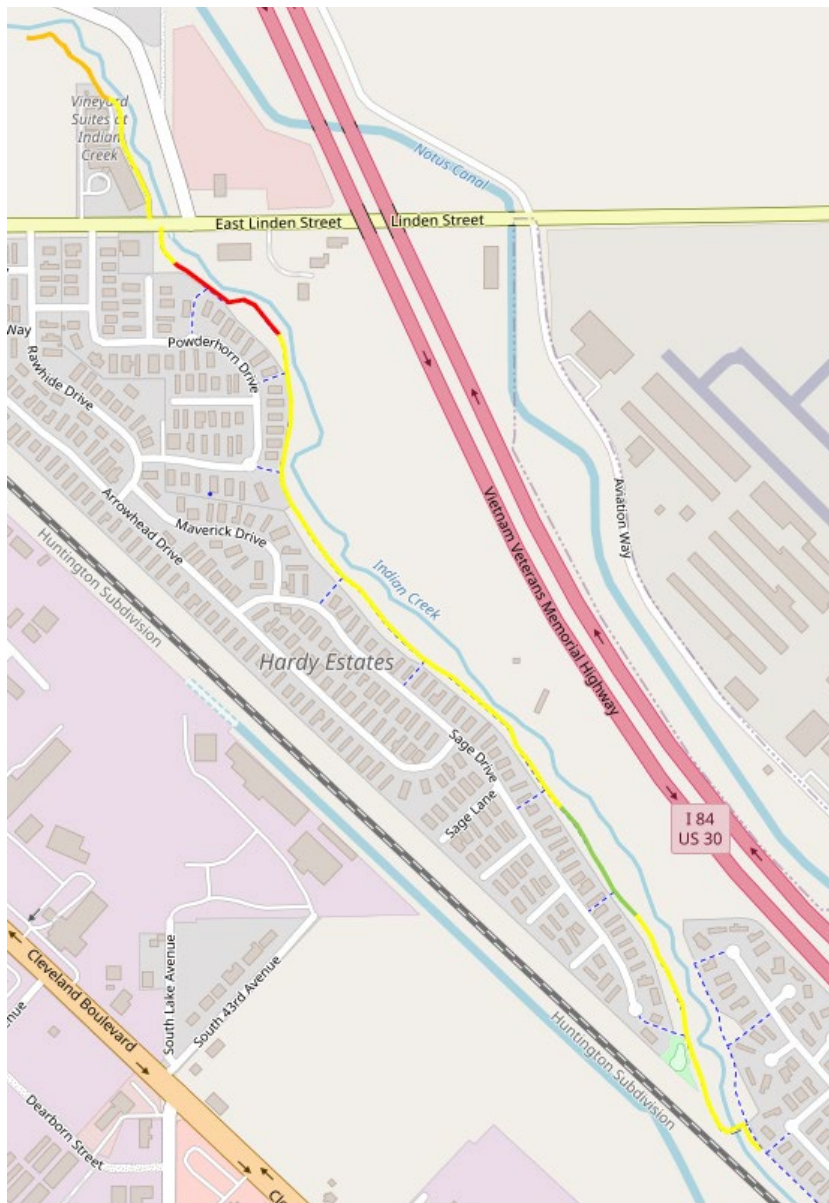
## Condition Maps

**C (4.6)**

**Location:** South of east Linden Street

**Primary Surface:** Asphalt

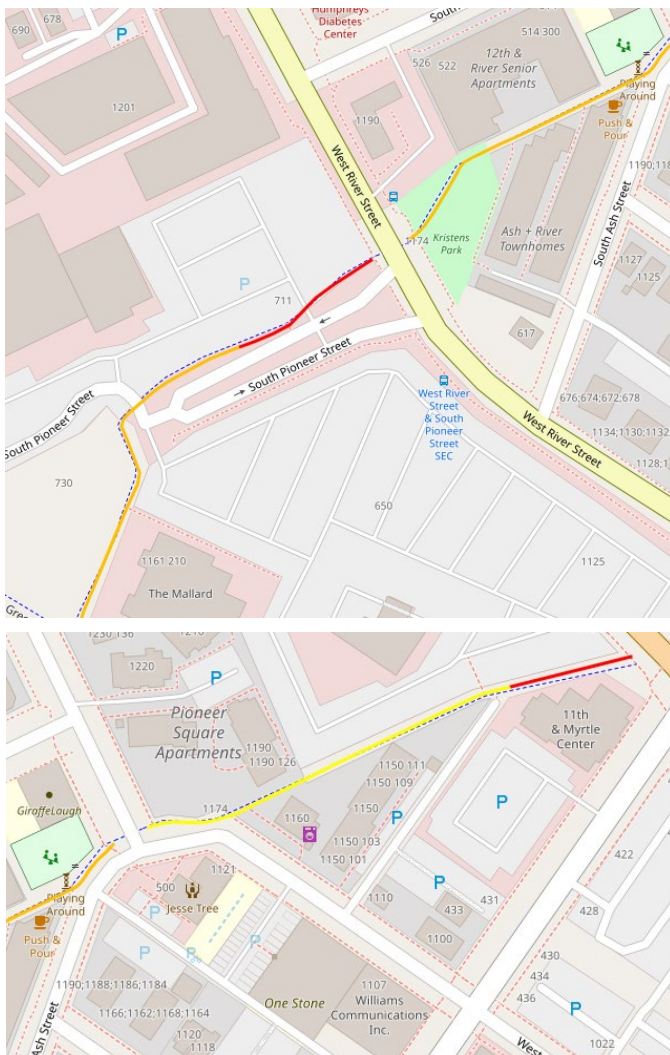
Condition Maps

**D (6.9)**

**Location:** Downtown connection to Greenbelt

**Primary Surface:** Pavers

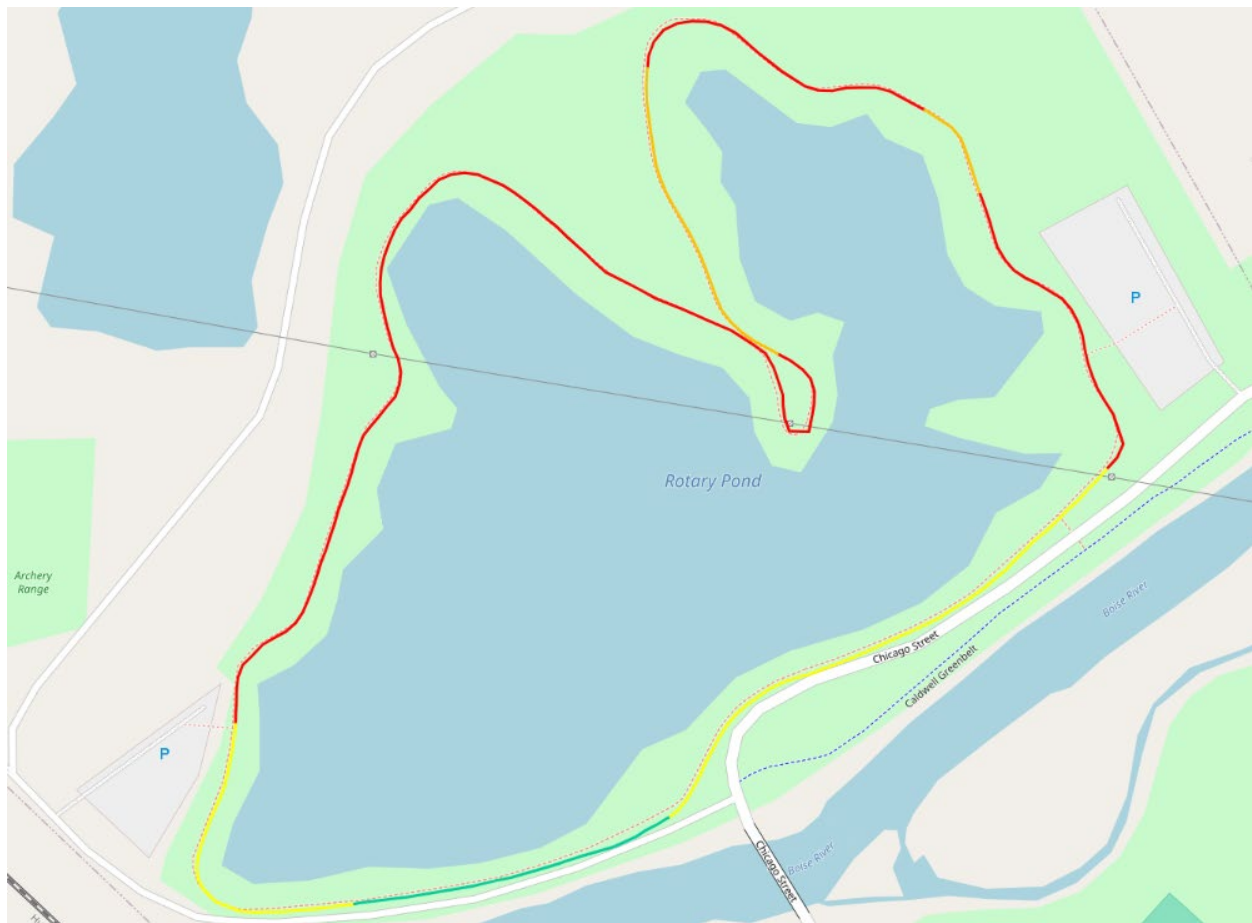
Condition Map

**D (6.8)**

**Location:** Rotary Pond  
**Jurisdiction:** Caldwell  
**Total length:** 1.01 miles  
**Primary Surface:** Asphalt

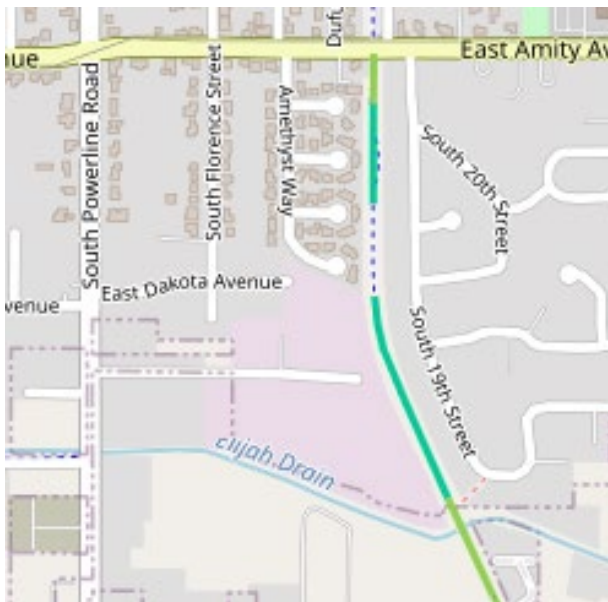
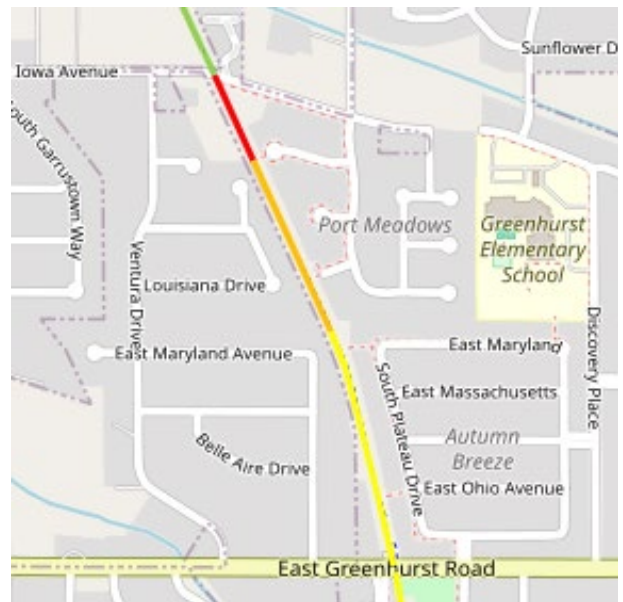
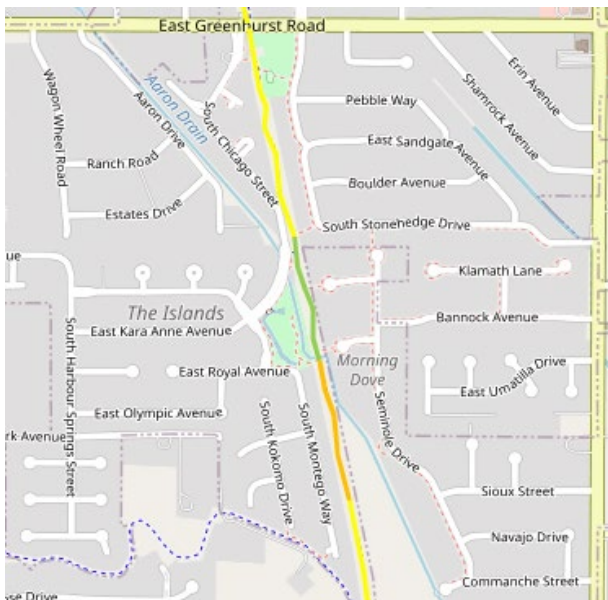
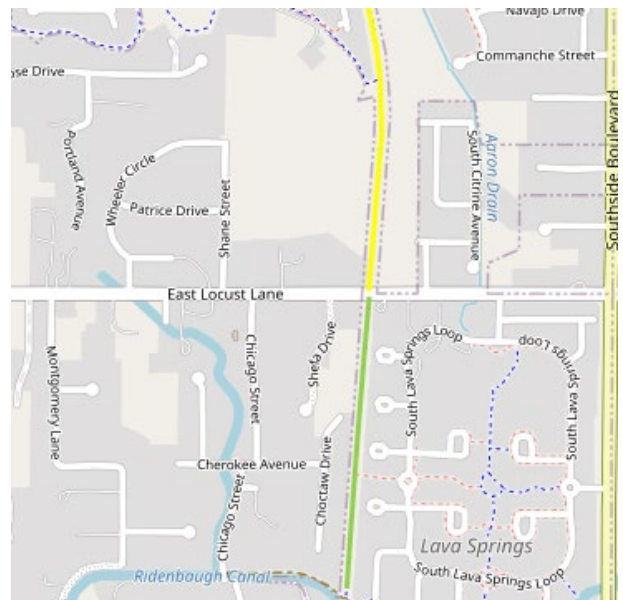
## Condition Maps

**C (3.7)**

**Location:** East Iowa Avenue to ½ mile south of east Locust Lane

**Primary Surface:** Asphalt

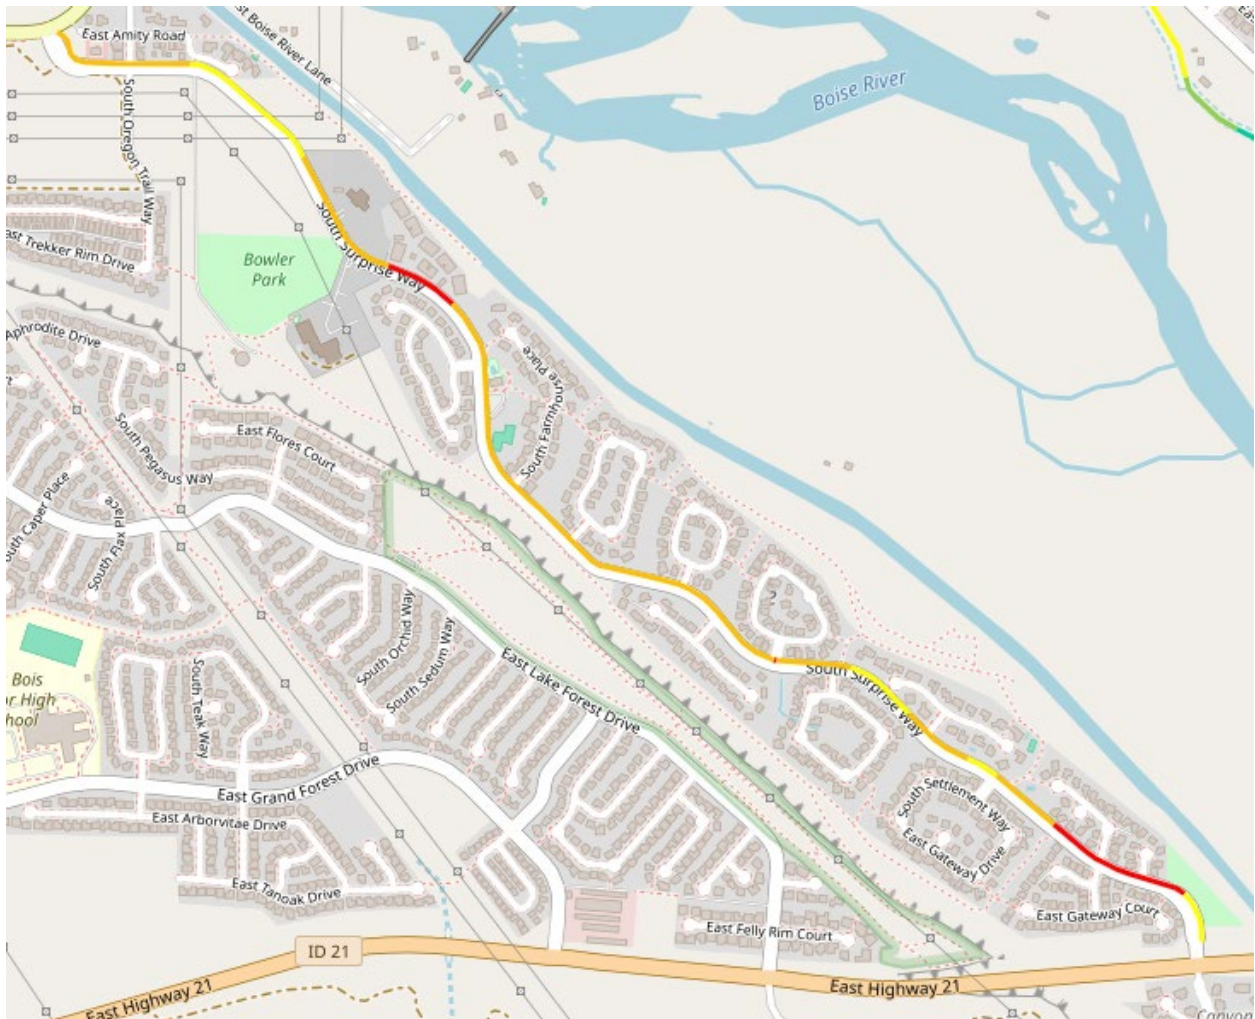
## Condition Map

**D (6.2)**

**Location:** South of East Amity Road north of State Highway 21

**Primary Surface:** Asphalt

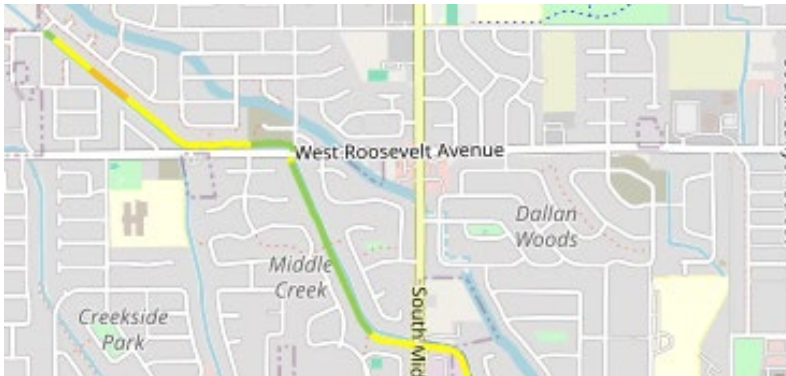
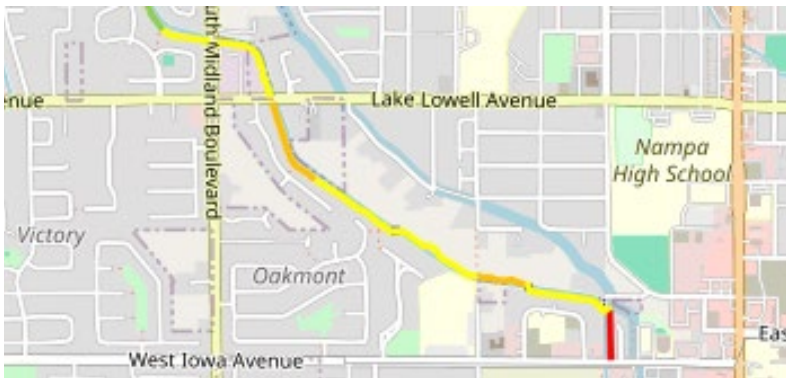
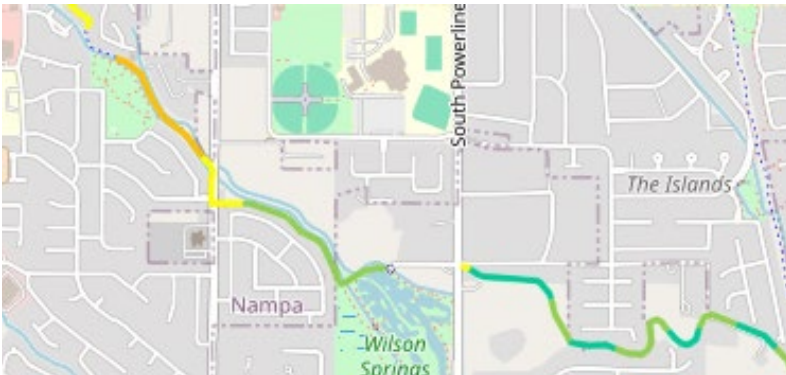
## Condition Maps

**C (4.0)**

**Location:** Follows the Wilson Drain from Sunnyridge Road to Roosevelt Avenue

**Primary Surface:** Asphalt
